THE SAN FRANCISCO-OAKLAND BAY BRIDGE SEISMIC SAFETY PROJECTS

EYEBAR REPAIR WORK SCHEDULED

ADDITIONAL EYEBAR REPAIRS

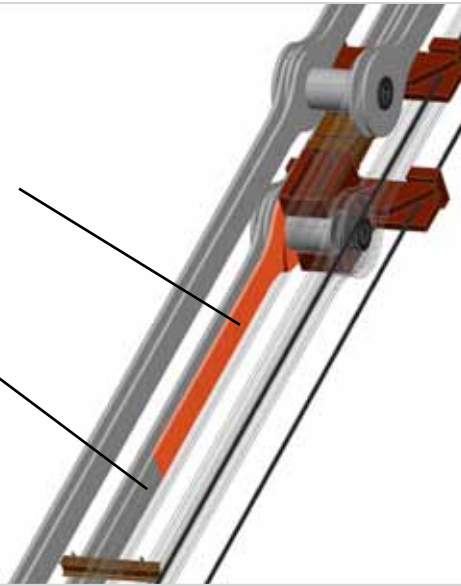
1

Cracked eyebar head and appx 12 feet of existing eyebar body are cut and removed

Connection holes for lower jacking bracket drilled
